1. INTRODUCTION

The Ecology and Environment, Inc. Field Investigation Team (FIT) was tasked by the U.S. Environmental Protection Agency (EPA) under Technical Directive Document (TDD) F06-9001-13 to conduct the Screening Site Inspection (SSI) Reassessment of the Goodson and Son Trucking facility in Channelview, Harris County, Texas.

1.1 SCREENING SITE INSPECTION OBJECTIVES

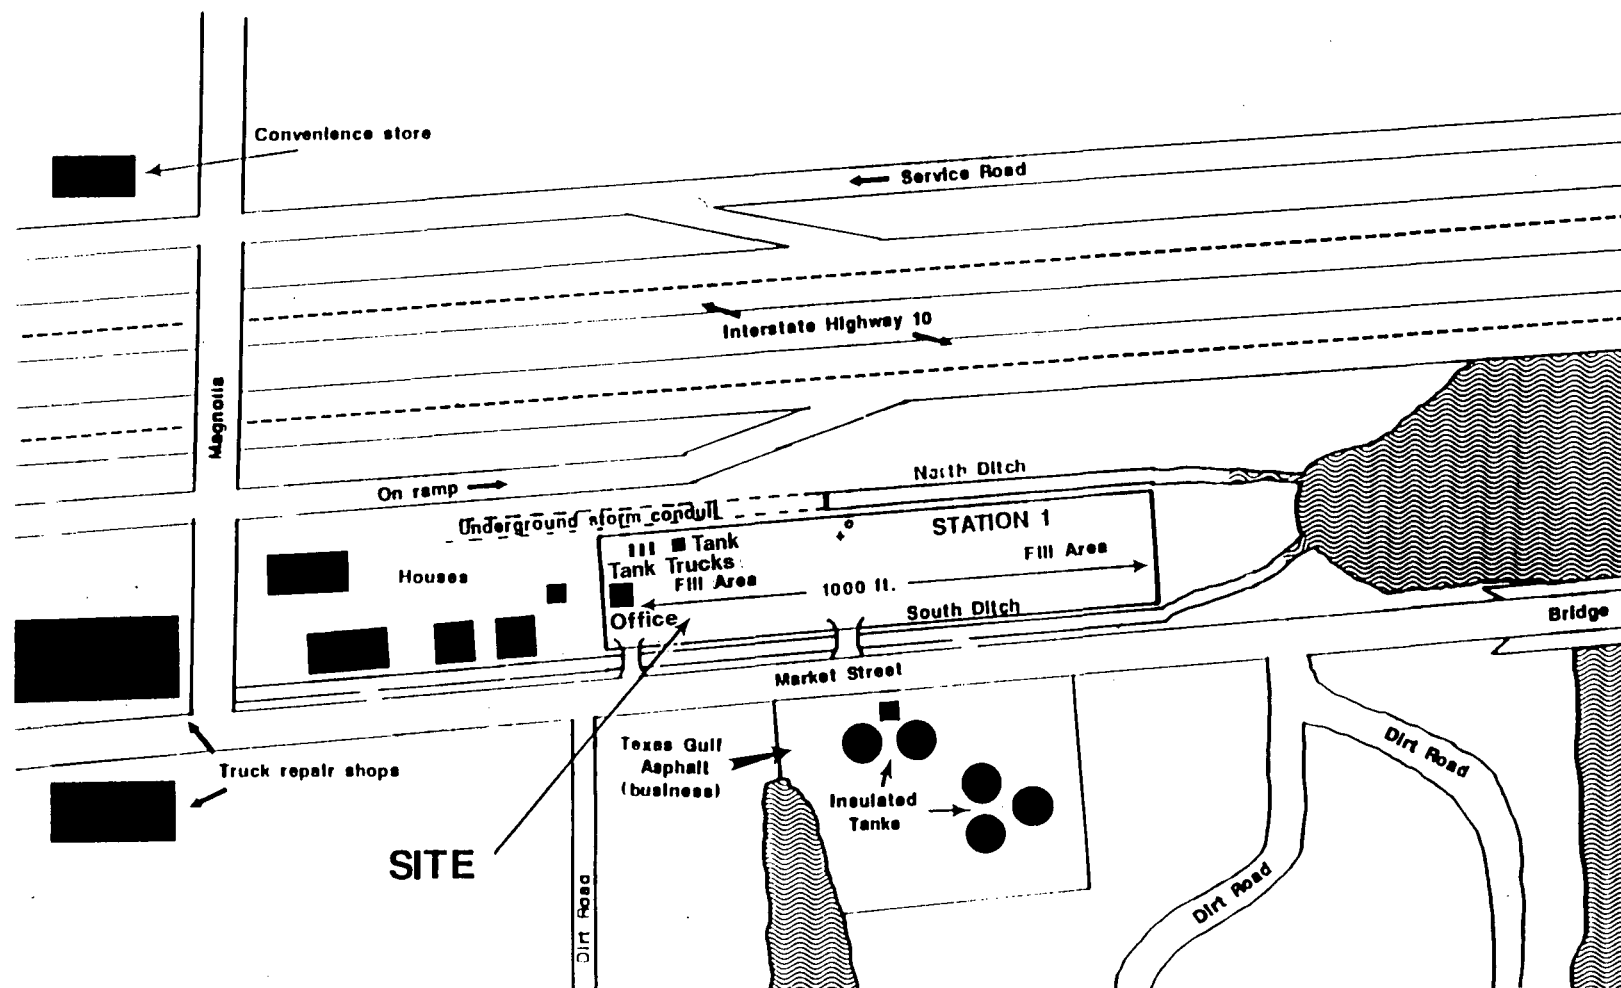
FIGURE 2
SITE SKETCH
GOODSON AND SON TRUCKING
CHANNELVIEW, TEXAS
TXD981052475

The site is located at 17300 Market Street, near I-10 and Lake Sandy, in Channelview, Texas (1) (Figures 1 and 2). The site originally existed as a low lying area. Solvents allegedly were dumped at the site, but there is no physical evidence to confirm this. The low area was filled with cement flue dust (cement fines resulting from the production of cement). The filled area is approximately 1,000 feet long by 200 feet wide by 8 to 10 feet deep.

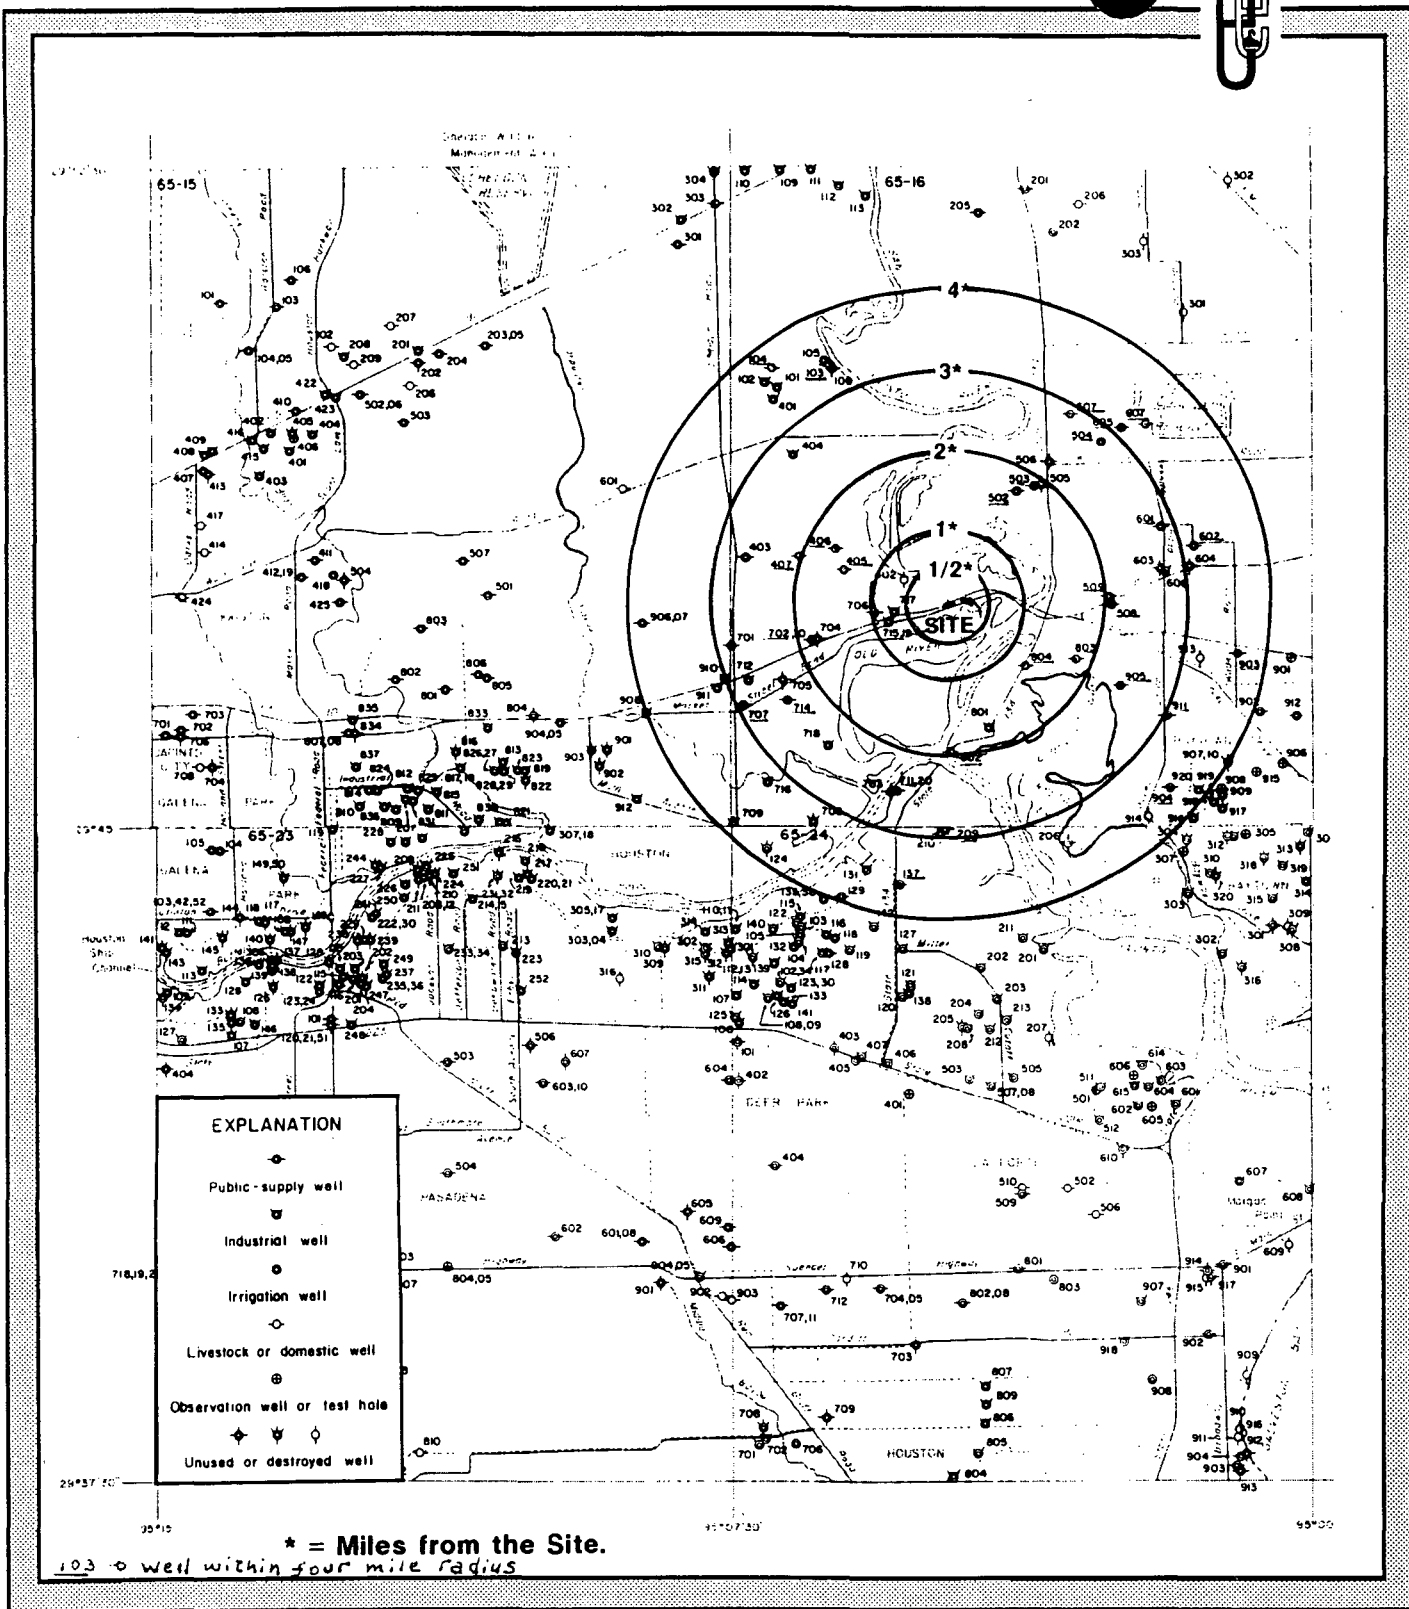
FIGURE 3
LOCATION OF WELLS WITHIN FOUR MILES OF SITE
WITHDRAWING WATER FROM THE CHICOT AQUIFER
GOODSON AND SON TRUCKING
CHANNELVIEW, TEXAS
TXD981052475

6. The site area is dependent upon ground water as a supply source for drinking water. The closest well to the site is located 1.2 miles southeast. Twenty-nine wells are located within a four mile radius of the site. Of the 29, 12 are public distribution wells for Harris County and the City of Baytown. These wells screen water from the lower Chicot Aquifer at depths between 375 and 660 feet. The closest of these wells is located 1.75 miles northeast of the site. Nine public wells are used for a private club, a state park, an inn, an estate and a highway department roadside park. The remaining eight wells are used for private residences, and most of them screen water from the Aquifer at depths between 270 and 440 feet. Water is screened only at a 100 foot depth from a well located three miles northeast of the site (Figure 3) (4; 7).
